# WRIGHTTIMES

November 2016

*Cure International*

*Santo Domingo, Dominican Republic*

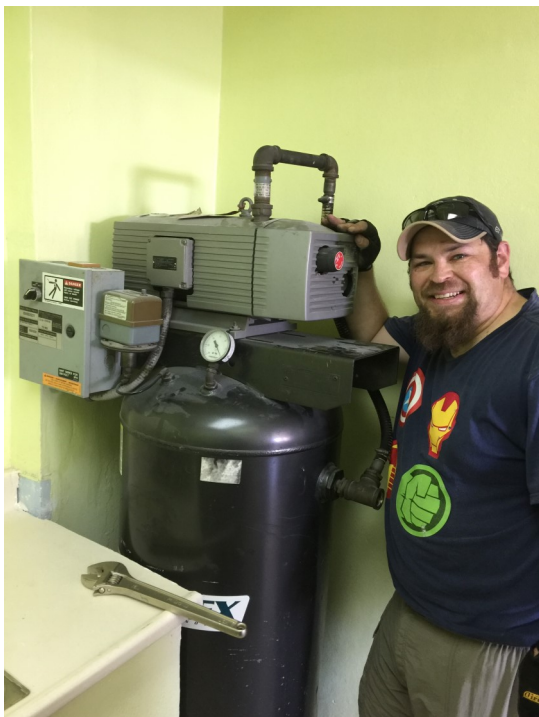
After making all the cultural connections after arriving on Monday morning, we got down to the tasks at hand. Moving the vacuum pump was no problem but fitting it into the new space presented some challenges. We ended up cutting the counter top and a piece of the mounting foot. It turned out to be a press fit but it is in place correctly. We developed a materials list for the electrical and piping fittings in moving the vacuum pump. I tried with examples to describe what I needed in very rusty Spanish but something is always lost in the translation. Not only did he purchase quantities different than requested but some unusual twists on parts. We finally had to laugh with him on the purchases. Our national contacts here realized with a little encouragement that Peter and I needed to go on the shopping trip. As we were at the large LOWE'S in the DR called Unidos, we had to change design several times based on items available. I must admit they had an awesome selection of items. It was a painfully slow process as we had to interface with several departments in the store but in the end, it all worked.

On our return, it became painfully obvious that the plastic PVC conduit we had on hand did not fit with the metal pieces we purchased. I tried heating the conduit and reforming it but it was so thin it did not conform to new shapes. I then tried slotting the conduit and it was moderately ok but not very elegant. We proceeded with as much enthusiasm as possible. The plumbing aspect went ok though.

We carefully checked over the wiring and then turned on the vacuum pump. It worked well and shut off at 25 IN Hg. My brief celebration was short lived. I opened the valve to the ORs and the pump would not shutoff. It did not have enough capacity to overcome a massive leak in the piping downstream. I checked all my connections and I could not identify a problem. Well, Sandra who is the head nurse of the OR area said the vacuum was a little bit better but.... I got changed into scrubs and went into the OR area. When I removed the vacuum outlet it suddenly dawned on me that the cleaning procedure with bleach water had nearly destroyed the electrical outlets and the oxygen and vacuum outlets were badly corroded. Normally, the medical gas outlets and backbody are a matched pair. When you remove a front outlet the valve in the back body or receiver shuts off the gas. Not so if one uses a Medical Air backbody and a Vacuum outlet. The gas is going the wrong way thus the valve never closes! The persons who installed the piped gas system used the wrong backbodies on both the vacuum and oxygen systems. Everything "LEAKS". Soooooooo, the combination of wrong parts installed incorrectly, small diameter piping, directional valves installed backwards by a previous national contractor had left them a system that underperforms to say the least.

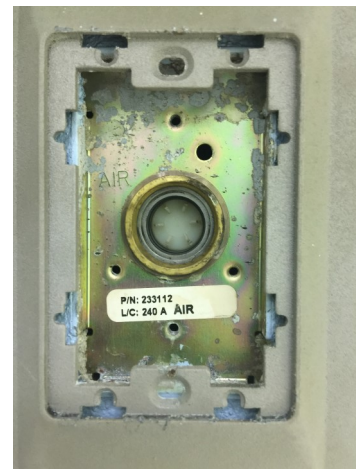
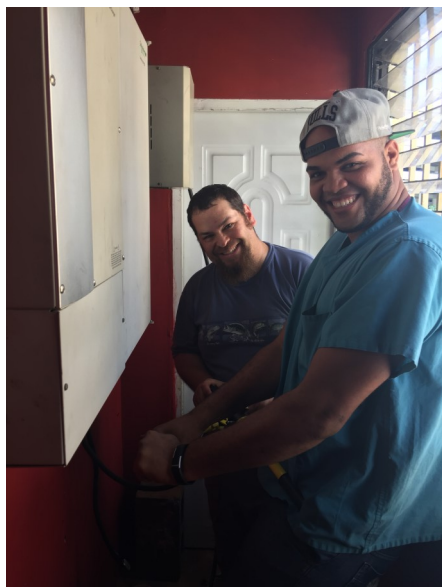
The maintenance staff of Cure removed the old batteries and corroded metal structure. They had fabricated a new metal base and we drilled for new anchors. The corrosion ate up the paint on the wall so I took a wire brush and removed the damaged paint. I asked them to paint and they brought Red Lead paint. Not sure what took place in the translation but I ended up operating the paint brush!?!?!

We installed the batteries in the Schneider inverter system. Each battery weighs about 100 LBs each and there is 8 of them. We tested each battery and they all looked ok.

After installing all the battery jumpers, it was time to turn it on. After a couple of parameter changes, the inverter booted up ok and synced with the GRID input and started charging the batteries. Brief celebration!
